# FOGBUSTERS, INC.

## CASE STUDY

- Customer:** 2 Sisters Food Group
- Location:** Morecambe, UK,
- Industry:** Chicken Roasting (120 tonnes per week)
- Install Date:** August, 2008
- Issues:** High chicken fat, causing screen pluggage, resulting in annual disposal cost of \$45,000. Downstream processes could not operate efficiently due to high fat resulting in high surcharges, compliance issues as well as odor problems.

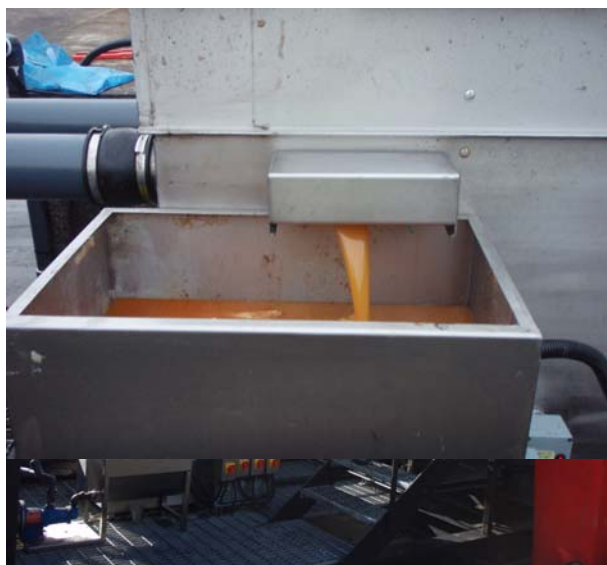
- Solution:** Fogbuster™ 1800, complete with solids removal augers, low shear pumps and fully automated control systems. Steam utilized due to the fast solidifying nature of the chicken fat and outdoor installation.

- Result:** The effluent now initially treated by the Forbuster system efficiently removes the solid debris before de-oiling the effluent. Wedge wire screen now works as designed to remove fine solids and carbon from the ovens. All downstream processes operating at peak efficiencies. Site is now compliant with the effluent standards required, odor was dispelled and sludge haulage costs significantly reduced. Surcharges have reduced by 80% and the bonus, recovered oil sales are yielding approx \$ 8,500 per month.
